Stage 1 Road Safety Audit

Proposed Works to Castlegar Road / Bóthar An Choiste (L5041) Road Junction, Castlegar Village, Galway

On behalf of Galway City Council

April 2022

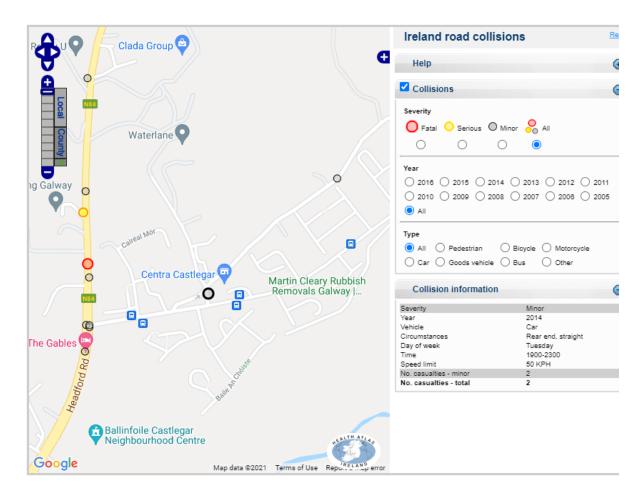
3.1 Collision Data

Road Collision Data available on the Road Safety Authority Database, within the period 2005 to 2016, recorded one collision in the immediate vicinity of the proposed site. This is shown as a "rear end straight" resulting in minor injuries.

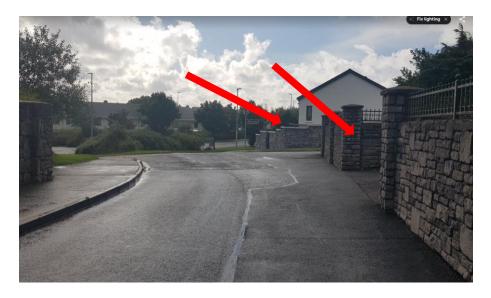
3.2.2 Junction visibility for Waterlane and adjacent private house

Problem: The proposals include for widening the existing Castlegar Road and will likely increase vehicle speeds on this road. Provision of future development off the road will also increase traffic volumes. It appears the northern road edge is to be moved further north and closer to both Waterlane and the adjacent dwelling house.

Hazard: Visibility when exiting both Waterlane and the adjacent private dwelling house is likely to be further compromised by the proposals.

Recommendation: Ensure adequate junction visibility is achieved for the junctions/accesses off Castlegar Road.

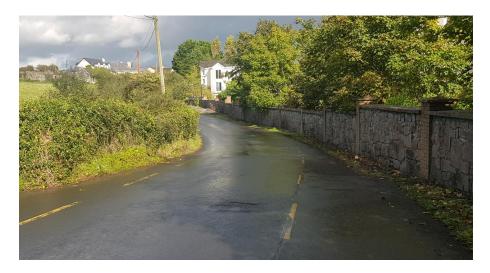
3.2.4 Road Serving Access to Future Development

Problem: The existing road leading to the future development lands is narrow and incorporates sharp bends with poor forward visibility and no footpaths.

Hazard: The future developments are likely to generate additional vehicular and pedestrian traffic on this road. Head on impacts between vehicles or pedestrian strikes may result.

Recommendation: Upgrade the road to provide adequate forward visibility, carriageway width and pedestrian facilities.

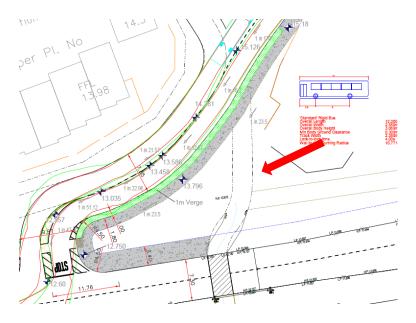
3.3.1 Existing Castlegar Road – Southbound Exit

Problem: The existing southbound exit lane is to be made redundant by the works. It is not shown if this road is to be broken out.

Hazard: Cyclists may continue to use this section of decommissioned road. Due to the steep downhill gradient, cyclists may errantly enter the Bóthar An Choiste (L5041) road and impact with traffic.

Recommendation: Remove the redundant road.

Note: Access to the ESB sub-station will need to be maintained.

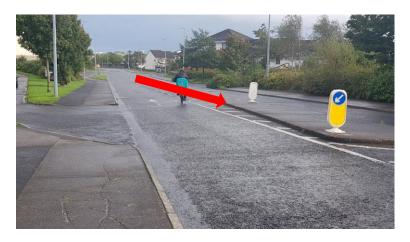
3.3.2 Bothar An Choiste (L5041) Central Median

Problem: There is an existing raised central median in the L5041 to the west of the proposed junction. The proposals include for removal of the existing right turning lane and associated hatch markings that lead up to this median.

Hazard: L5041 traffic may strike the raised median.

Recommendation: Remove the raised median.

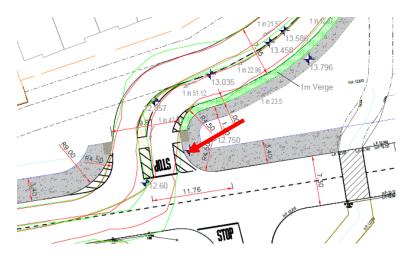
3.3.3 Hatch Markings to Road Edge

Problem: Hatch markings are shown to the east of the new junction, in the area of the uncontrolled pedestrian crossing.

Hazard: Pedestrians may stand in the area of road hatch, believing this area is safe and not for vehicle use. These pedestrians may be struck by the trailing wheels of long vehicles.

Recommendation: Adjust the design such that nearside hatch markings in the area of pedestrian crossings are not required.

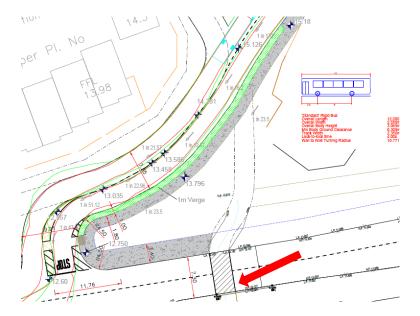
3.3.4 Bothar an Choiste (L5041) Road Markings

Problem: There are road markings proposed at a location for pedestrians to cross Bothar an Choiste (L5041) that are non-standard.

Hazard: Motorists may be confused as to what to do here and slow down stop in the carriageway and be rear-ended.

Recommendation: Ensure any road markings comply with the Traffic Signs Manual.
