## **Stage 1 Road Safety Audit**

**Strategic Housing Development at Bóthar An Choiste,  
Castlegar, Galway**

On behalf of Lock House Developments Ltd

**July 2022**

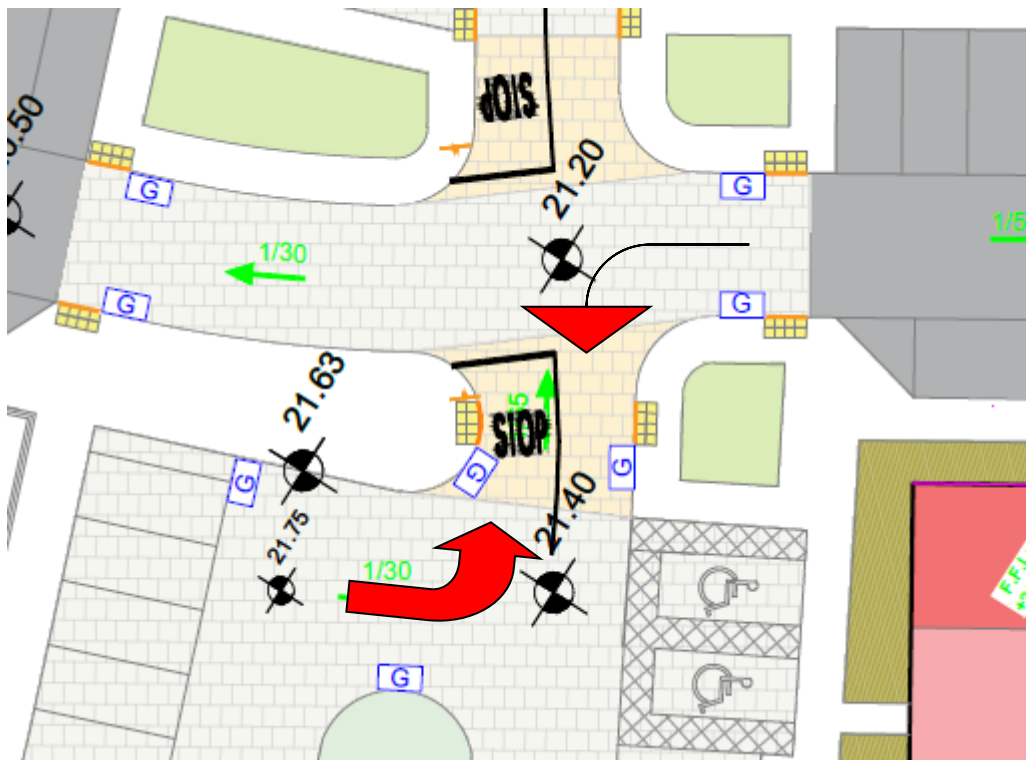
#### 3.3.3 Proximity of Junctions

**Problem:** The exit from the parking area is close to the entry off the spine road.

**Hazard:** Entering traffic may impact with the left turning exiting vehicle.

**Recommendation:** Ensure sufficient separation of junctions to avoid potential conflict.
