Stage 1 Road Safety Audit

Proposed Works to Castlegar Road / Bóthar An Choiste (L5041) Road Junction, Castlegar Village, Galway

On behalf of Galway City Council

April 2022

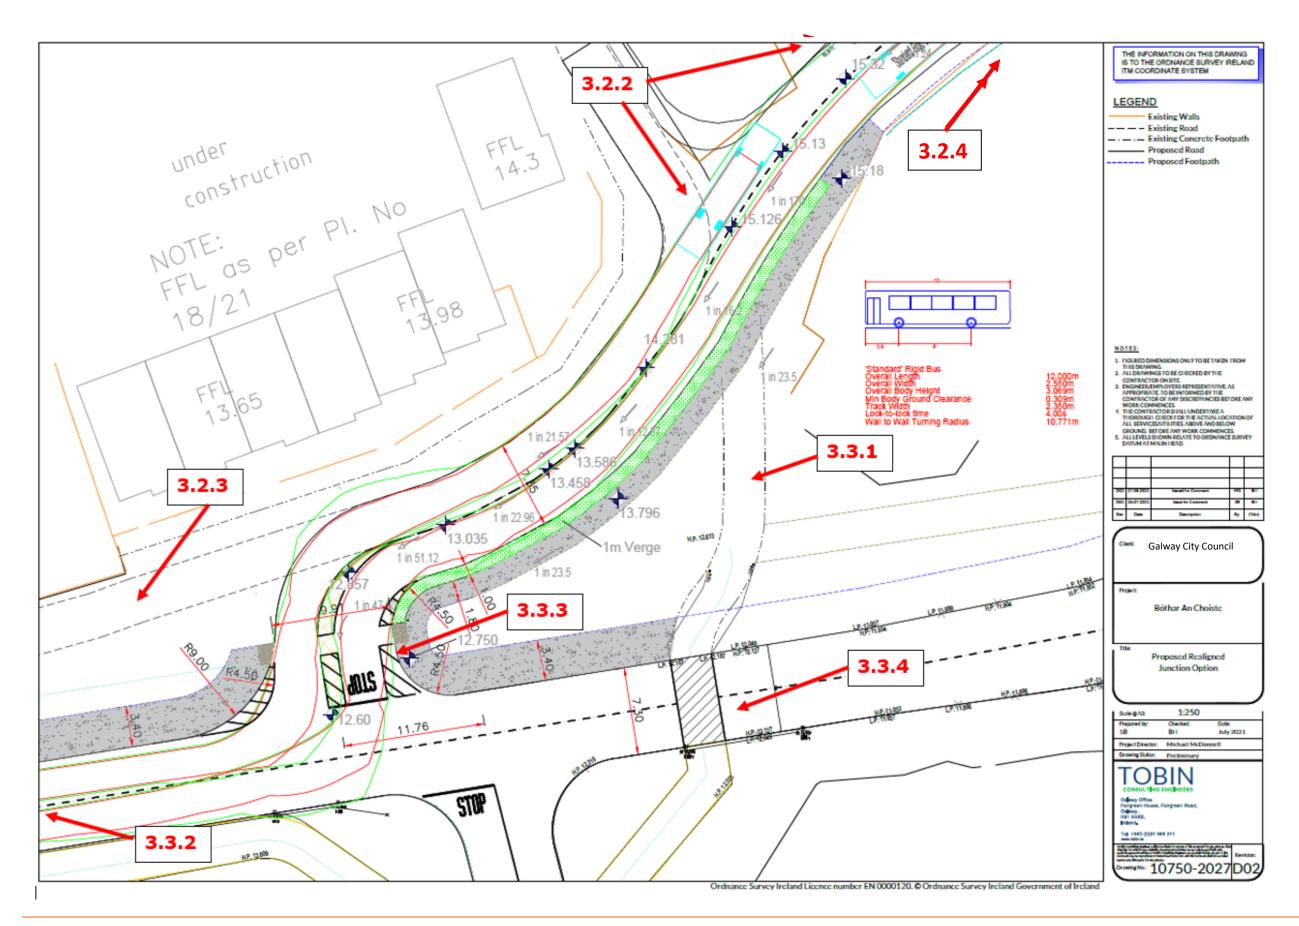
Appendix B Problem Location Plan

Hazard: Visibility when exiting both Waterlane and the adjacent private dwelling house is likely to be further compromised by the proposals.

Hazard: Road users may errantly believe this road is available for use and strike the new kerb.

Hazard: The future developments are likely to generate additional vehicular and pedestrian traffic on this road. Head on impacts between vehicles or pedestrian strikes may result.

Problem: The existing southbound exit lane is to be made redundant by the works. It is not shown if this road is to be broken out.

Hazard: Cyclists may continue to use this section of decommissioned road. Due to the steep downhill gradient, cyclists may errantly enter the Bóthar An Choiste (L5041) road and impact with traffic.

Hazard: L5041 traffic may strike the raised median.

Hazard: Pedestrians may stand in the area of road hatch, believing this area is safe and not for vehicle use. These pedestrians may be struck by the trailing wheels of long vehicles.

Hazard: Motorists may be confused as to what to do here and slow down stop in the carriageway and be rear-ended.

Recommendation: Ensure adequate junction visibility is achieved for the junctions/accesses off Castlegar Road.

Recommendation: Break out and landscape the redundant element of road.

Recommendation: Upgrade the road to provide adequate forward visibility, carriageway width and pedestrian facilities.

Recommendation: Remove the redundant road.

Recommendation: Remove the raised median.

Recommendation: Adjust the design such that nearside hatch markings in the area of pedestrian crossings are not required.

Recommendation: Ensure any road markings comply with the Traffic Signs Manual.
